Capital Improvements Division

SEMSWA's Pipe Rehabilitation Program

Molly Trujillo, PE, CIP Manager
Jon Nelson, PE, CIP Project Manager

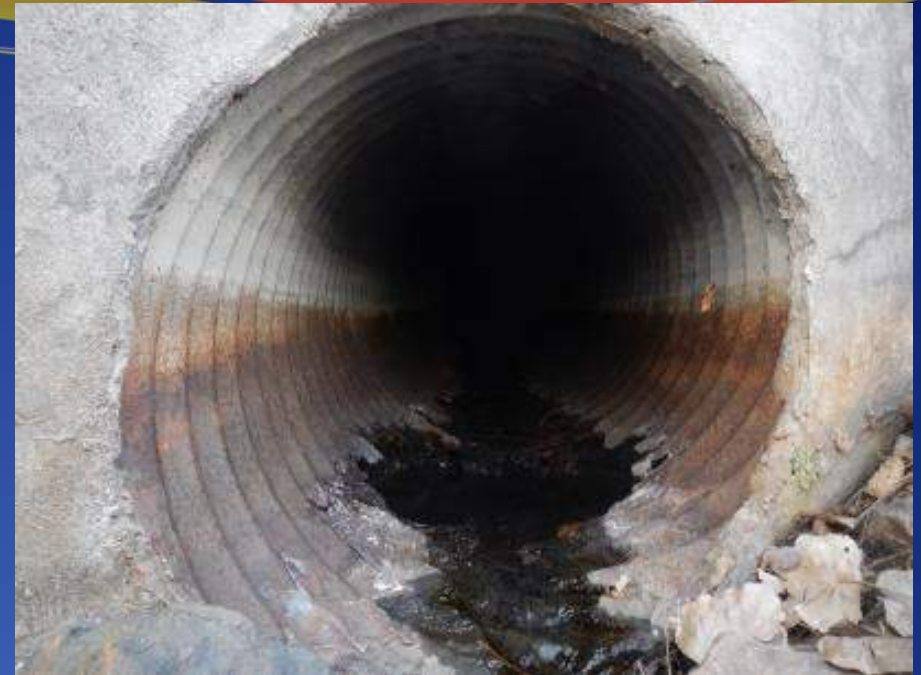
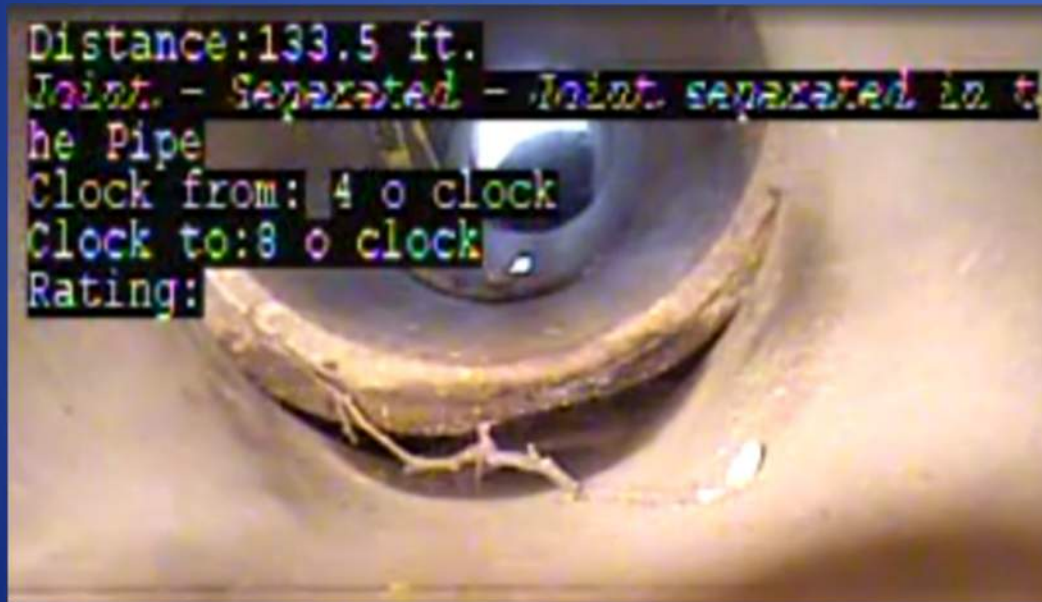
Corrugated Metal Pipe (CMP):
CMP deteriorates, corrodes, rusts and disintegrates overtime especially along the bottom of the pipe.

Reinforced Concrete Pipe (RCP):
Joints Separate, Concrete deteriorates and cracks.

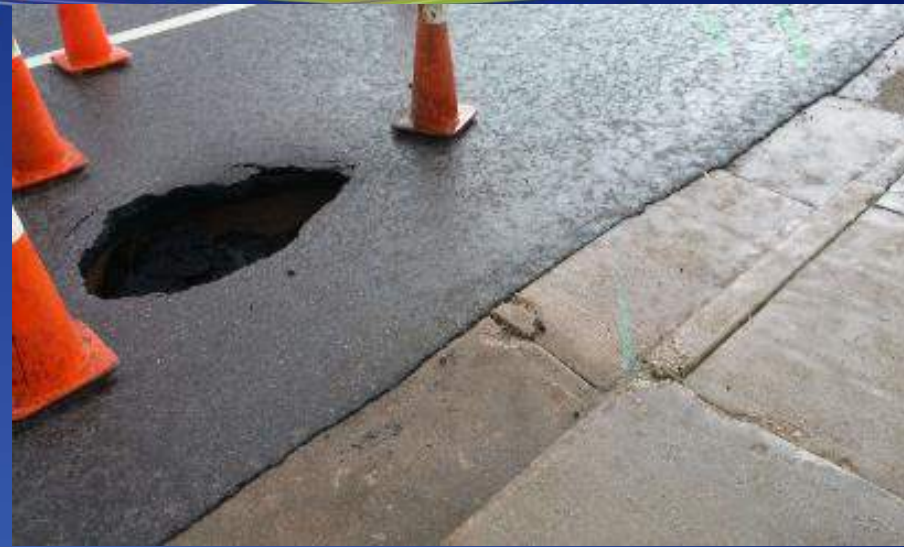
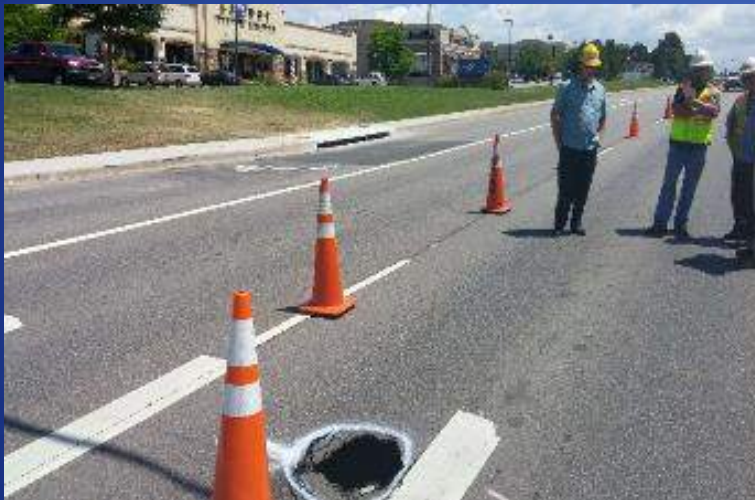
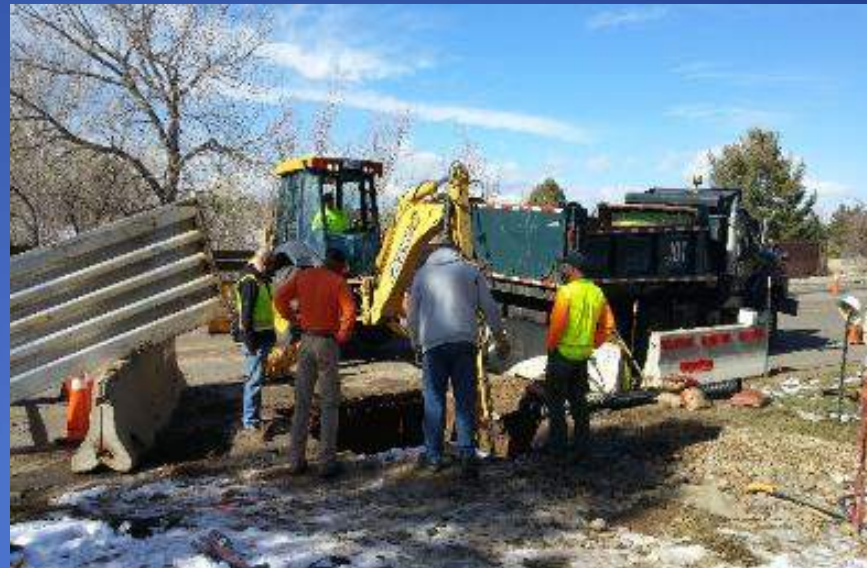
Once pipe is compromised water infiltrates and can erode the pipe bedding and soils around the pipe, potentially causing sink holes, compromising safety, roads, and other infrastructure both public and private.

Repairs become very costly and disruptive...

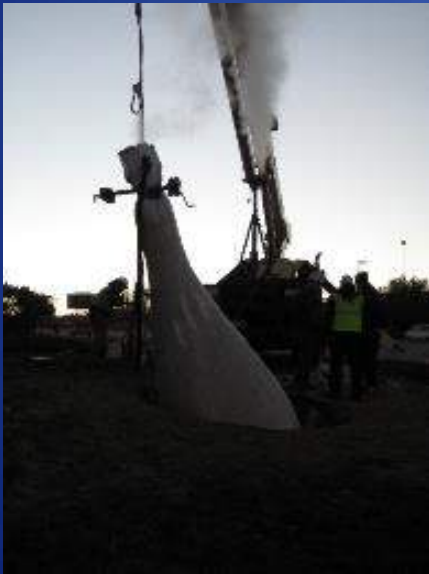
In 2011 sinkholes began to form along the 60" CMP alignment running under County Line Road at Chester St. Pipe inspection revealed several holes along the invert of the CMP.

Pipe re-inspected in March of 2018, liner was observed to still be in excellent condition after ~6 years of service.

SEMSWA partnered with the City of Lone Tree to install CIPP within the CMP. Total project cost ~\$160,000. Completed over the course of a week (October, 2011) with minimal disruption to traffic. Direct replacement estimated at ~\$350,000.

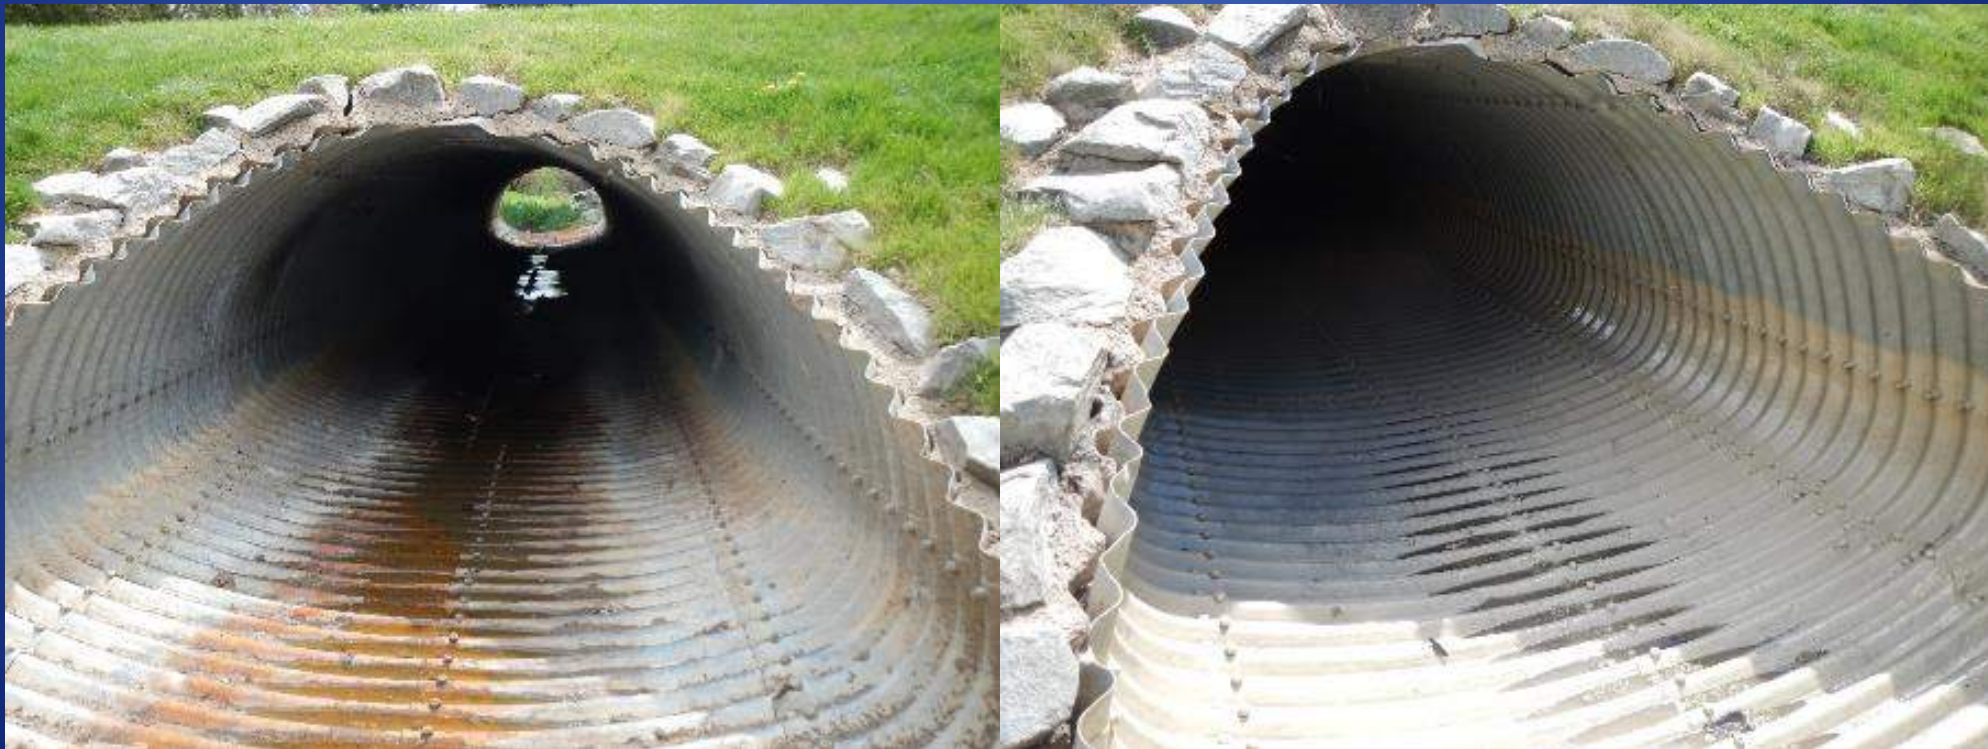
Site visit in March 2018 confirmed the CMP and the liner is still in good condition.

2014 SEMSWA used a Polyurethane Spray on product to line and protect the bottom of an 80” x 132” arch CMP crossing for the Phillips tributary at E Phillips Pl.

Project cost ~ \$26,000.00. Very economical solution to extend the life of existing CMPs in poor but not critical condition

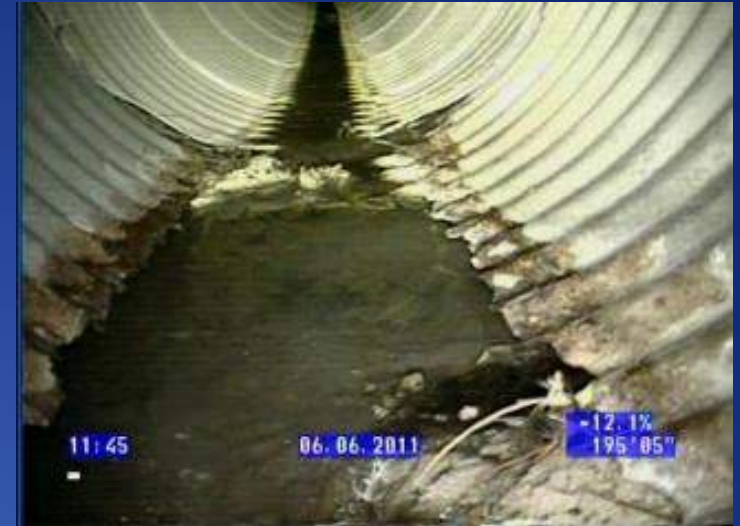
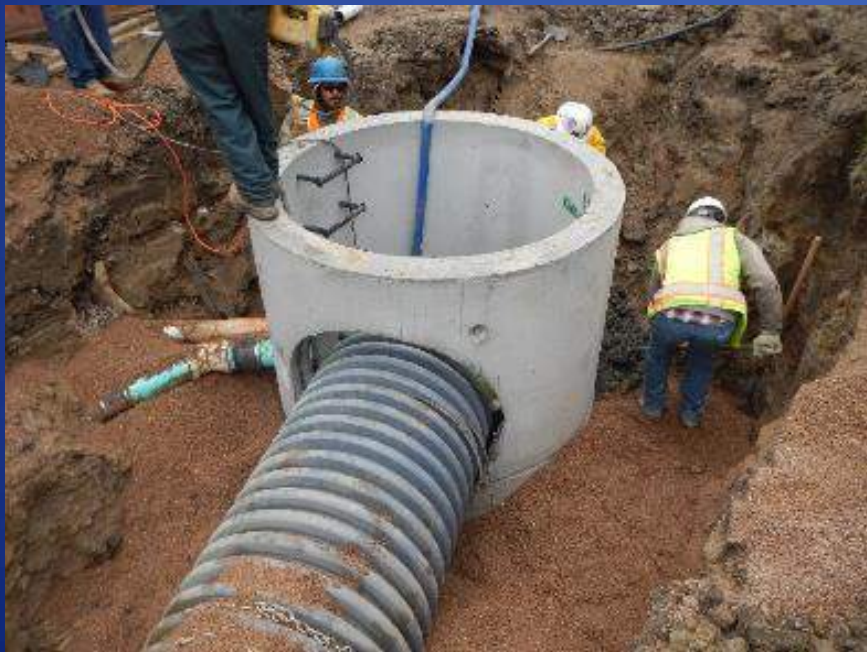
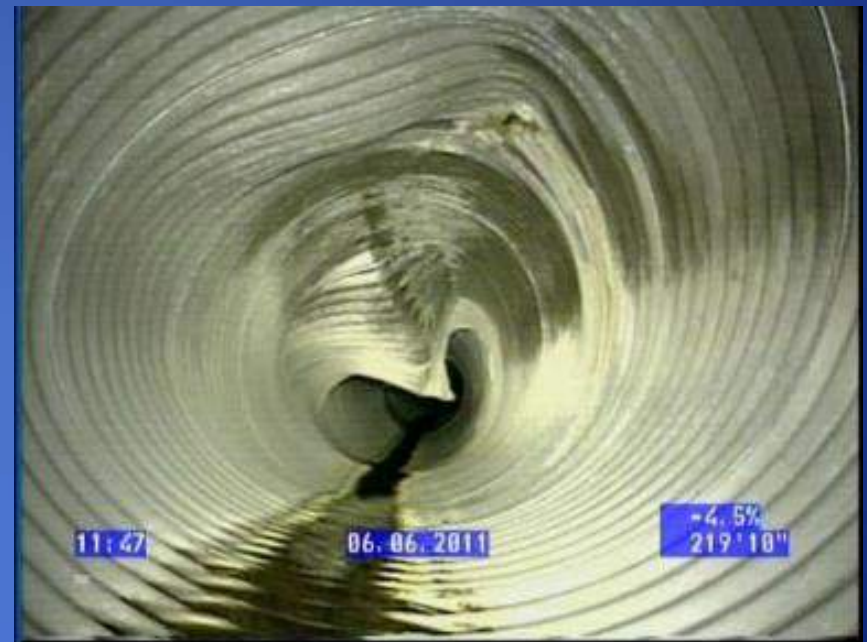
2015 SEMSWA replaced a severely damaged and corroded 30" storm sewer within a green belt near E Mineral Drive and S Vincennes Way.

Pipe deformation eliminated the option of relining the CMP. SEMSWA utilized High Density Polyethylene (HDPE) storm sewer in lieu of the traditional Reinforced Concrete Pipe (RCP). Lower risk site provided a good location for a case study of HDPE and it's performance over time.

Replaced ~ 350 lf of CMP, project cost ~ \$75,000.00.

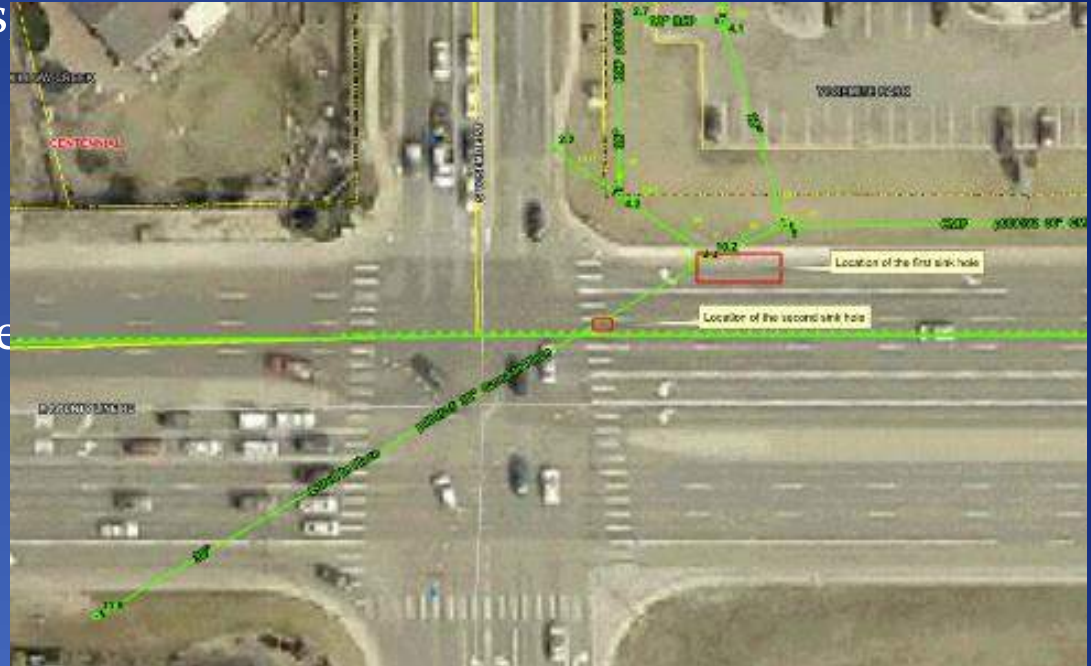
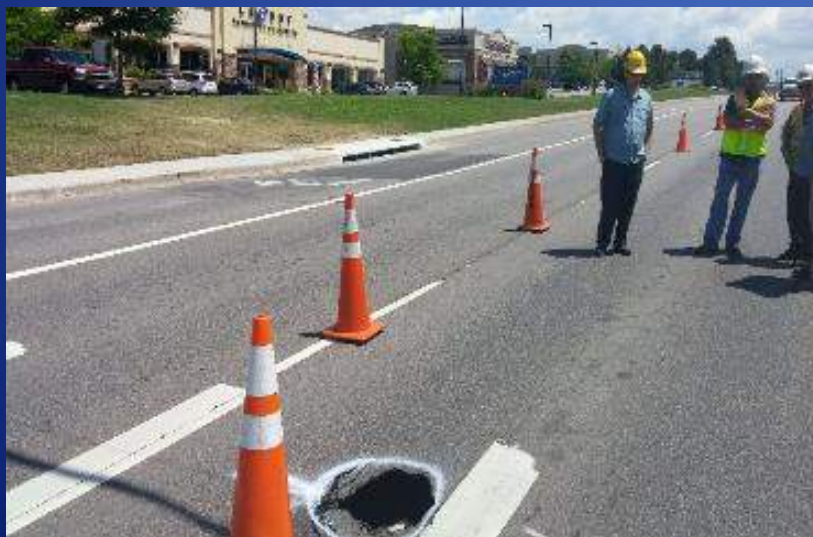
2015 – Higher than usual precipitation led to the formation of several sinkholes including 2 on County Line Rd. and Yosemite St. along the alignment of a 36” CMP. Emergency repairs included flash filling the sink holes and relining the 36” CMP running under County Line Rd.

Sinkhole repair work - \$34,100

310 LF 36” CIPP - \$64,000

Fortunate timing allowed SEMSWA to acquire the lining at a heavily discounted price, since Insituform had a “wetted out” 36” liner that they needed to get rid off.
~Estimated savings of \$60,000.
