September 10-15, 2013

Assessing Storm Event Impacts

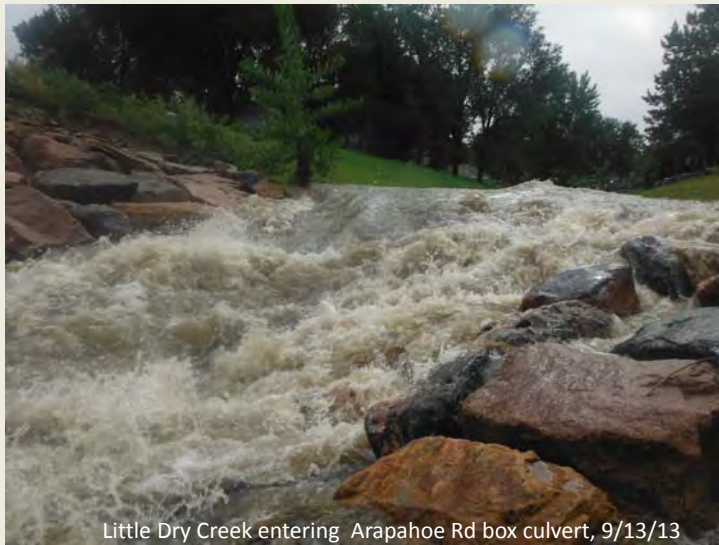
Little Dry Creek entering Arapahoe Rd box culvert, 9/13/13

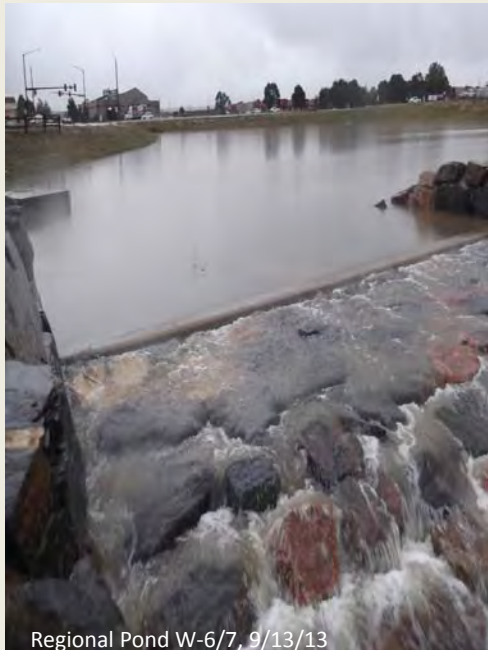
Regional Pond W-6/7, 9/13/13

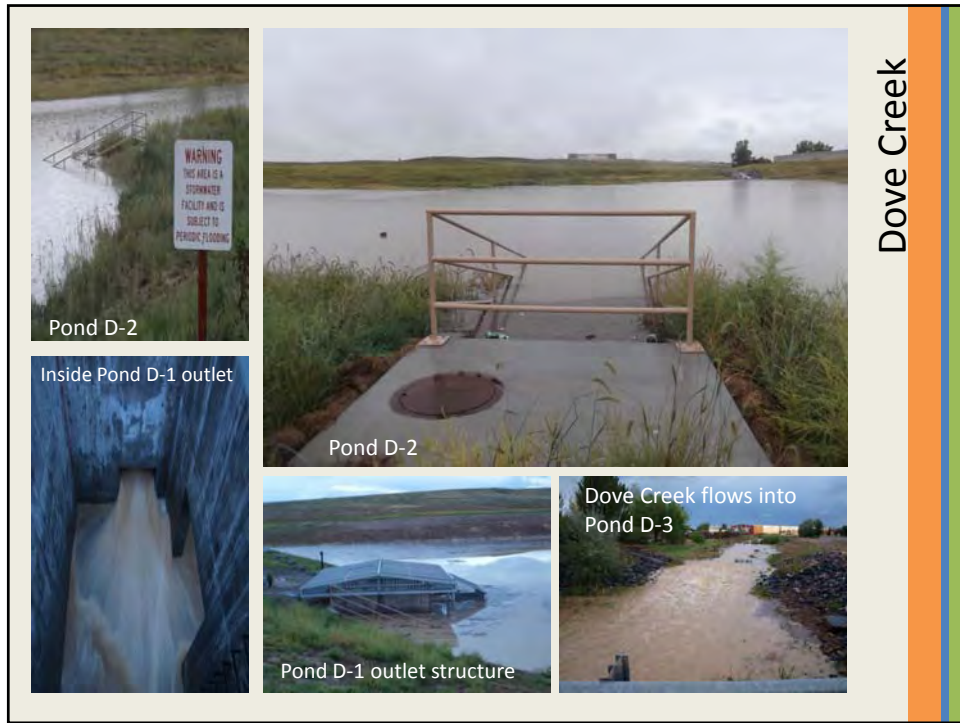
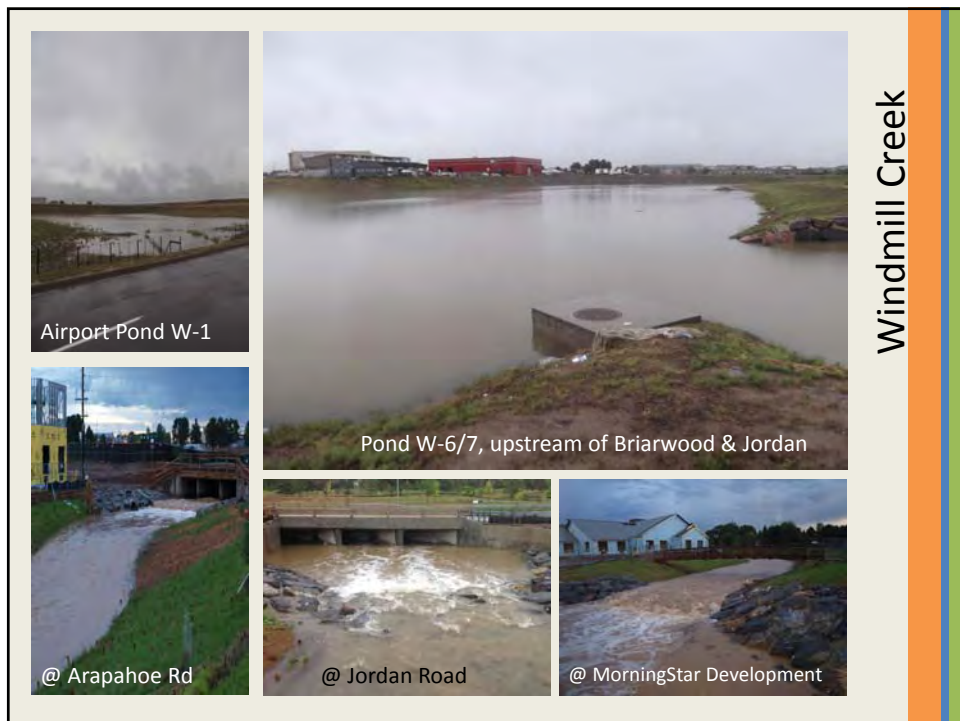
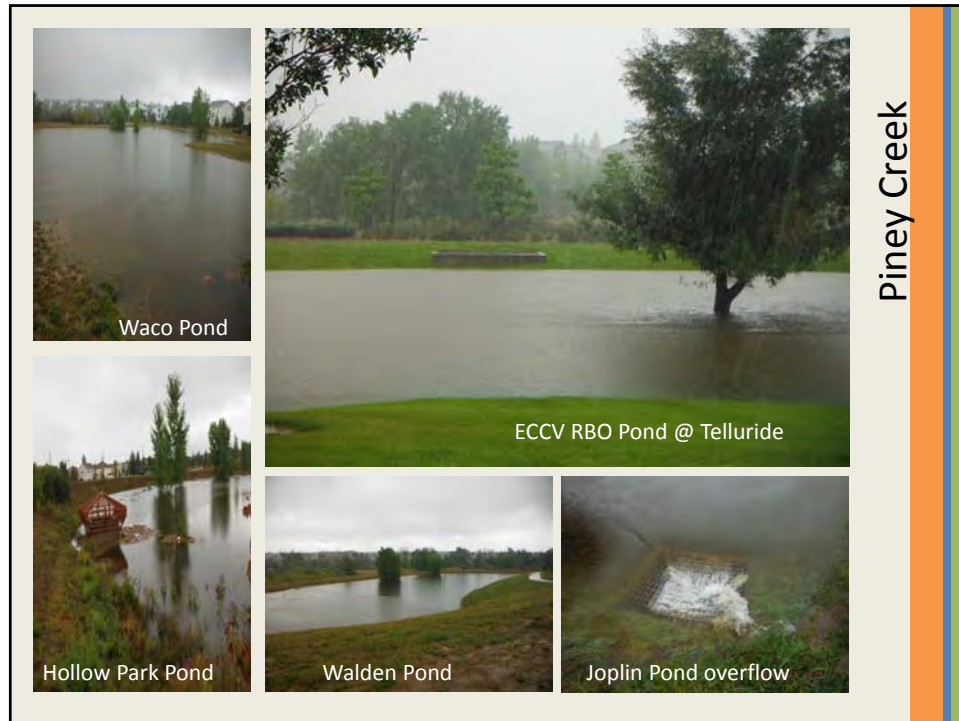
Let's see what some Regional ponds looked like during the storm event...

Regional Ponds are very effective at detaining peak flows, protecting downstream facilities from higher and more erosive flows....

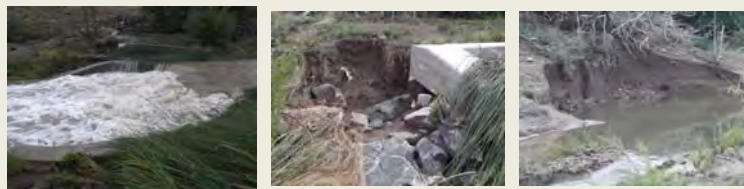
The Cottonwood Creek Stream Stabilization project would have benefitted from a master planned, but not yet completed Regional pond, immediately upstream @ Easter.

SEMSWA CIP Program has this Regional pond In design now in response to increased Inverness area development....

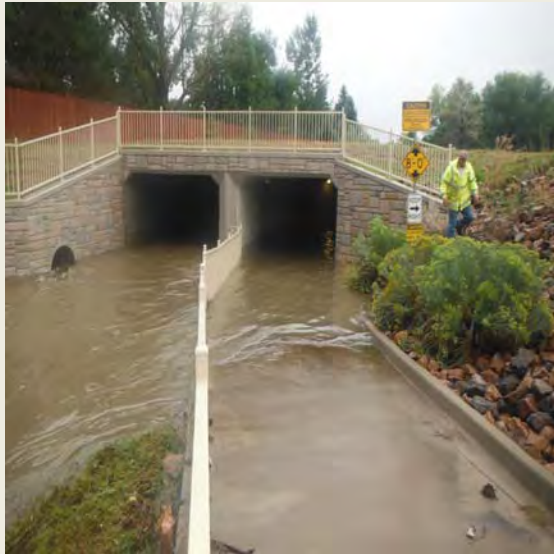
Little Dry Creek @ Arapahoe, downstream of road

While the flows in Centennial were not of the magnitude as those experienced in the northern part of the State and in neighboring Aurora and Parker, the antecedent rains from early in the week saturated the ground and caused the later rains to immediately runoff and increase flows in our creeks. This type of storm, regardless of intensity, often results in damage to downstream facilities.

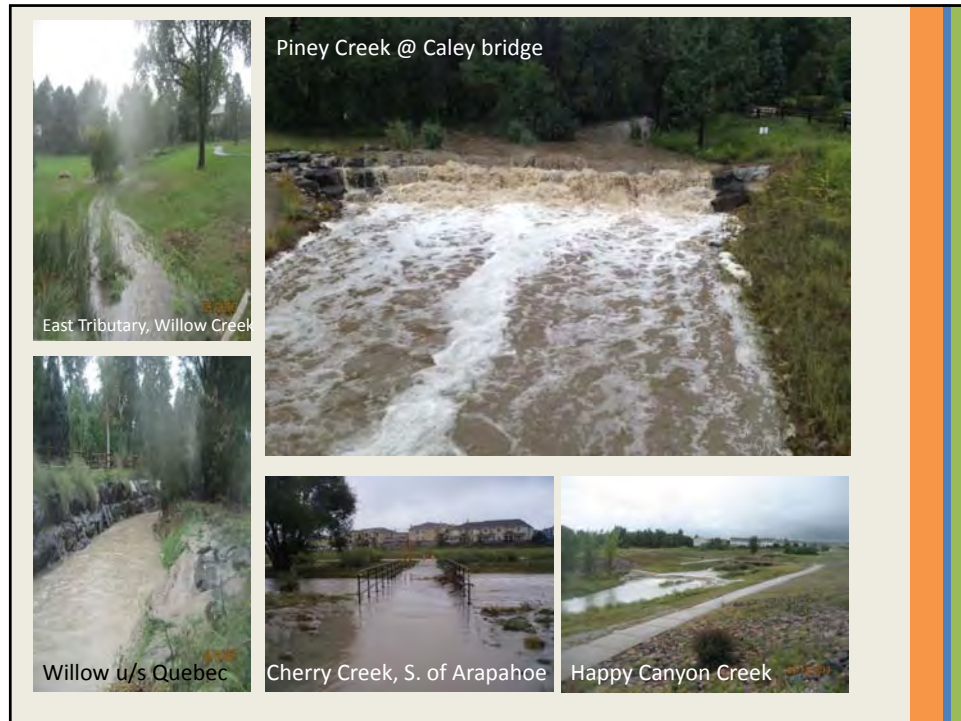
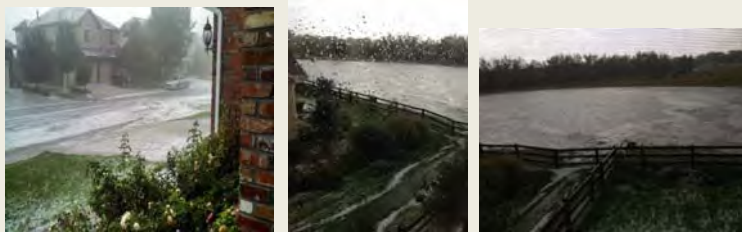
Pictures sent in by Stephanie Piko, Centennial Council Member, showing the drainage swale SEMSWA completed in 2007.

Council Member Piko noted how well the swale worked, taking the significant street flows to the detention pond, and how well the pond released flows to Piney Creek and took on new flows from the swale throughout the storm event.

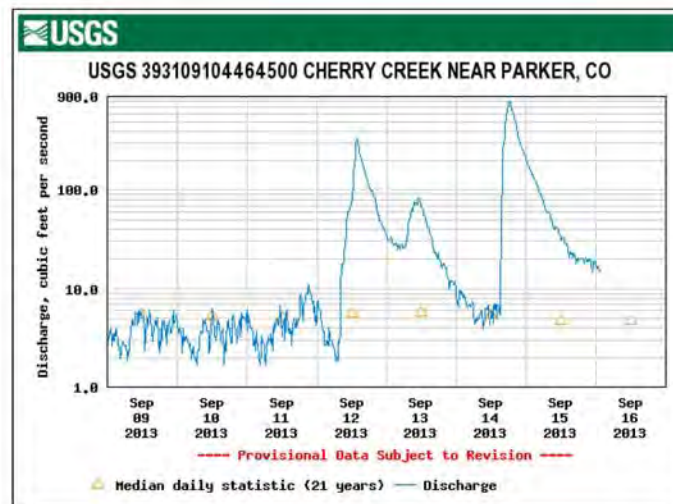
Cherry Creek hydrograph illustrating peak flows from
September storm events @ the Main Street gage
