# Lee Gulch Stream Restoration

## 2024 Stream Rehabilitation Project Preliminary Timeline

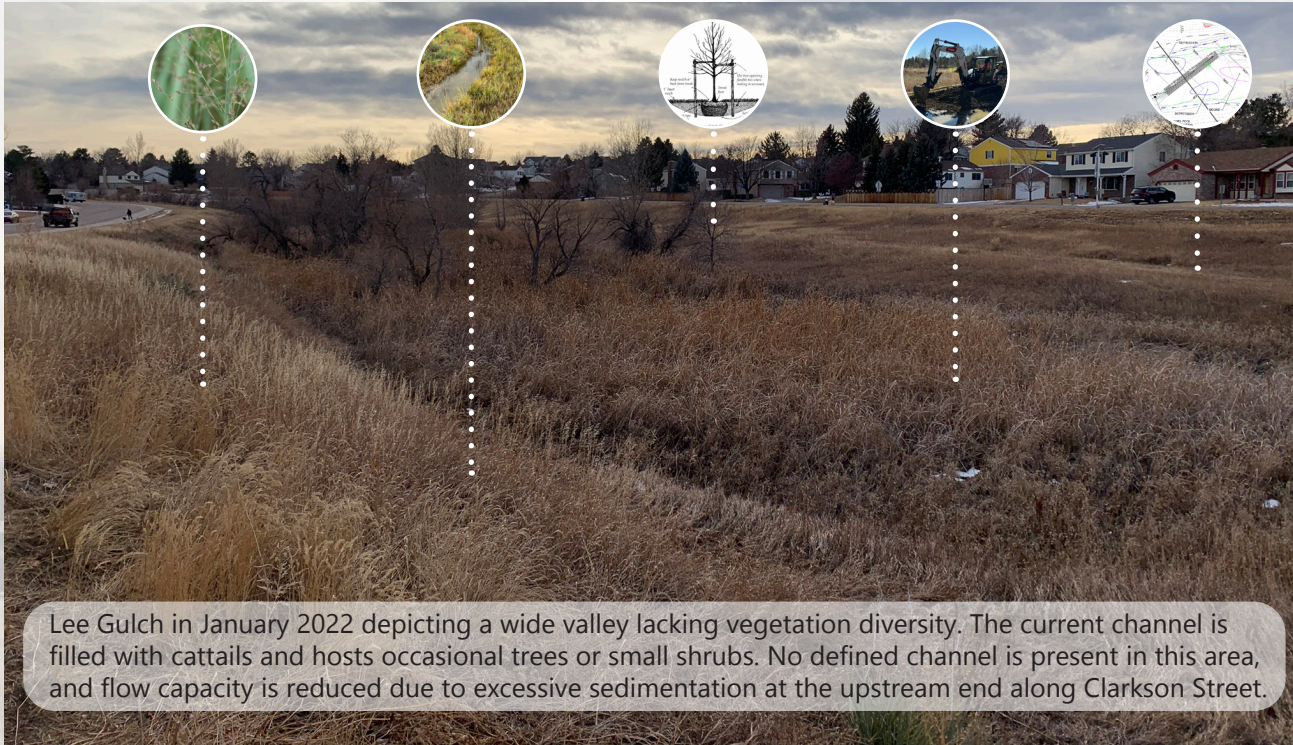
Lee Gulch in January 2022 depicting a wide valley lacking vegetation diversity. The current channel is filled with cattails and hosts occasional trees or small shrubs. No defined channel is present in this area, and flow capacity is reduced due to excessive sedimentation at the upstream end along Clarkson Street.

Over time, sediment accumulation from storm events have deposited into Lee Gulch, which has reduced flow capacities and degraded the natural stream corridor. Sediment accumulation has also blocked the culvert under Clarkson Street, and has lead to flows overtopping the road during larger storm events, creating a public safety hazard.
