Capital Improvements Division

SEMSWA's Pipe Rehabilitation Program

Molly Trujillo, PE, CIP Manager
Jon Nelson, PE, CIP Project Manager

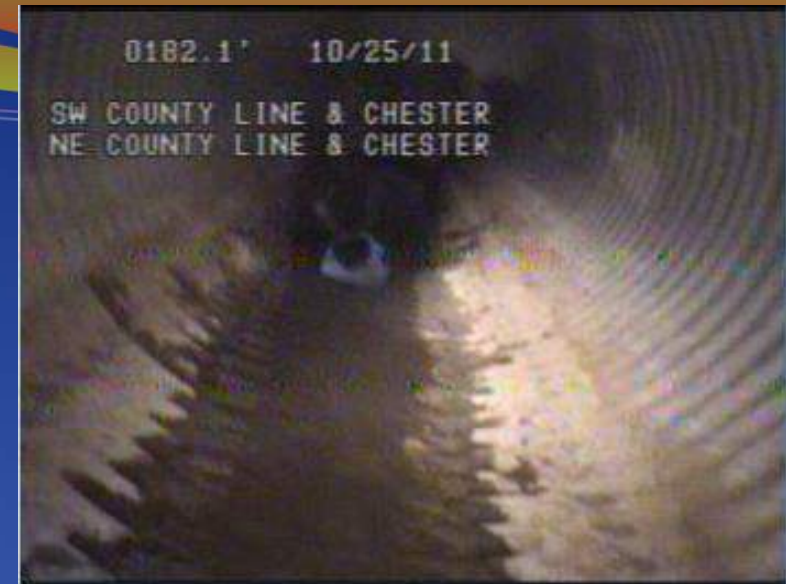
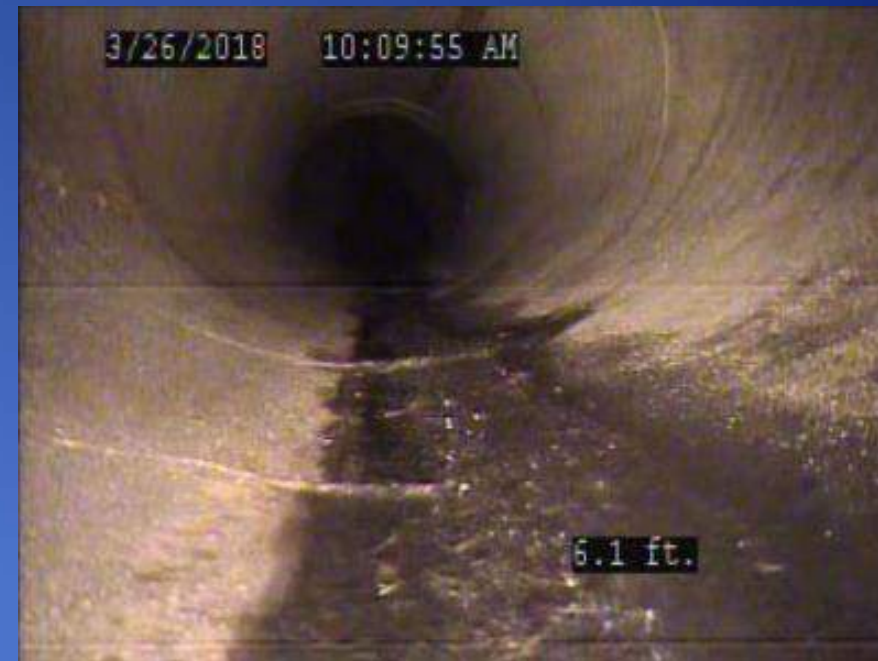
In 2011 sinkholes began to form along the 60" CMP alignment running under County Line Road at Chester St. Pipe inspection revealed several holes along the invert of the CMP.

Pipe re-inspected in March of 2018, liner was observed to still be in excellent condition after ~6 years of service.

SEMSWA partnered with the City of Lone Tree to install CIPP within the CMP. Total project cost ~\$160,000. Completed over the course of a week (October, 2011) with minimal disruption to traffic. Direct replacement estimated at ~\$350,000.

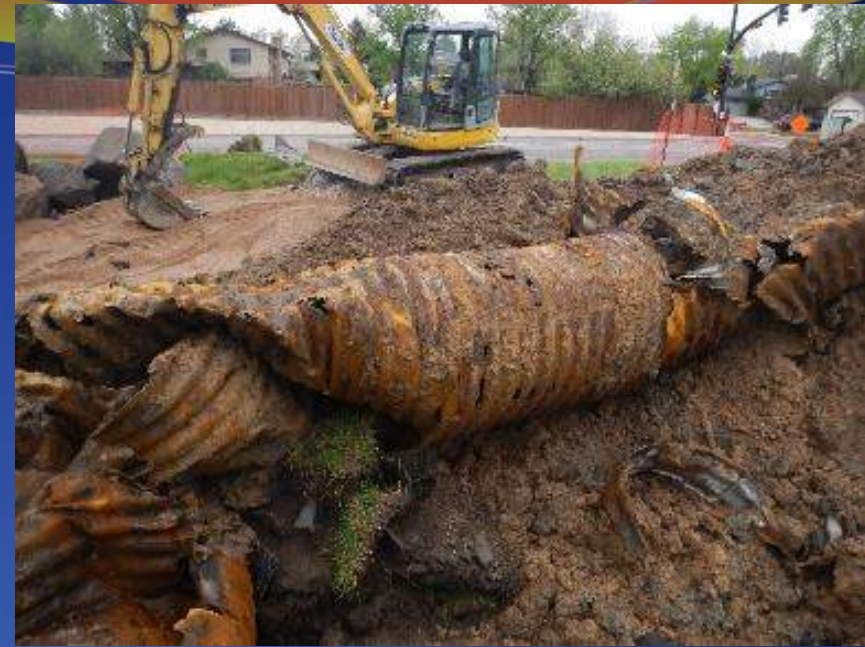
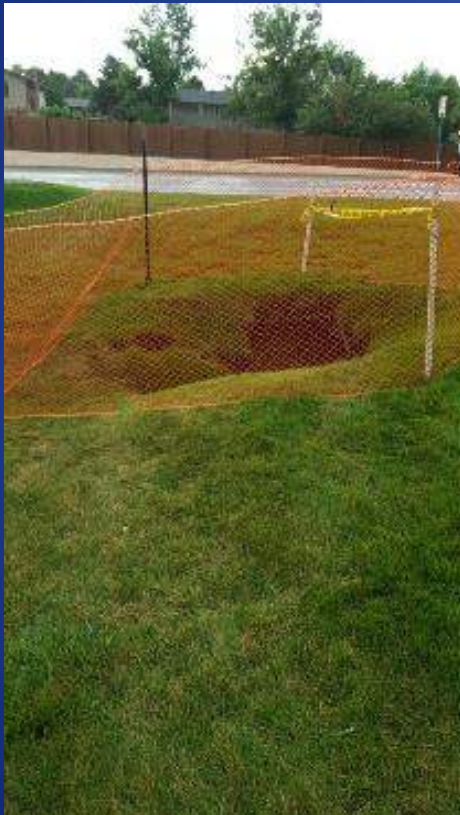
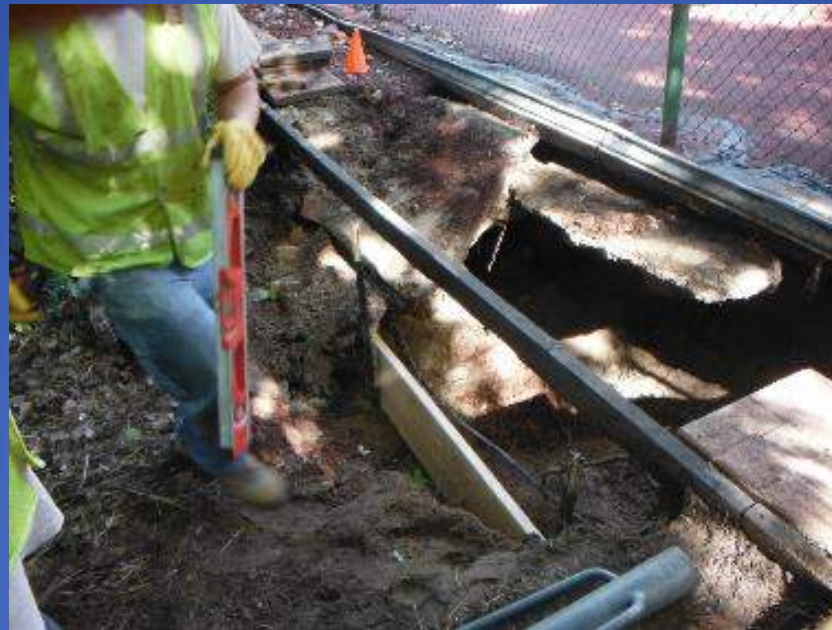
As of June, 2012 SEMSWA had identified 41,109 linear feet of CMP within its service area, of which nearly 10,000 linear feet was classified as being in “Poor” or “Critical” Condition.

2012 SEMSWA began to allocate \$800,000 per year to address the deteriorating CMPs within the SEMSWA jurisdiction.
